# FORENSIC INVESTIGATIONS GET TO THE FACTS

## East Side IHNC Flood Wall Breaches during Hurricane Katrina

By W. Allen Marr, PE, PhD, D.GE, NAE, F.ASCE

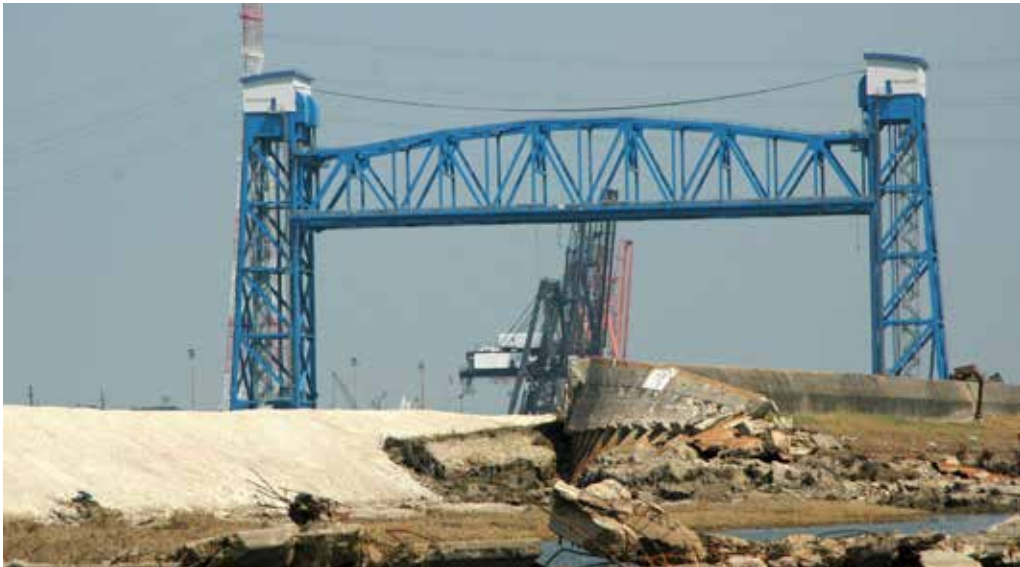
**Figure 1.** Failed flood wall near the Florida Avenue Bridge. (Photo courtesy of U.S. Army Corps of Engineers.)

The two breaches, referred to herein as the North Breach and South Breach, occurred as the water level in the canal rose to unprecedented levels. The North Breach, located about 150 ft south of Florida Avenue, occurred around 6 am and opened to approximately 210 ft wide (Figure 1). The South Breach, located 870 ft north of North Claiborne Avenue, started around 7-8 am and opened to approximately 820 ft wide (Figure 2). Water flowed through these breaches at very high rates and was responsible for a major portion of the flooding of the Lower 9th Ward. Once the floodwaters started to recede, water slowly flowed out of the Lower 9th Ward through the breaches until the pumping system drew the internal water level below ground. Subsequently, the USACE constructed rockfill dikes to provide temporary closure of these and other breaches.

After studying the old and new data and the results of many analyses, I concluded that a structural failure in the I-wall concrete and steel sheet piling at the transition between the wall's construction in 1969 and 1980 initiated the North Breach. Several more inches of horizontal translation of the flood wall section to the south of this transition compared to the north section caused the sheet pile to stretch along its horizontal axis. The section to the north had longer sheet piles and more soil mass on the land side; thus, it was inherently stiffer than the section to the south. The weak soils and relatively low ground level on the land side of the flood wall produced a relatively low factor of safety (FOS) against global stability, which resulted in greater relative lateral displacement.

elements, to the point that the two sections of sheet piling just south of the 1969-1980 intersection deformed plastically along their horizontal axis by a substantial amount. These sections were recovered and the plastic deformations measured.

As the sheet piles started to elongate along their horizontal axis, they stretched the concrete wall sitting atop the sheeting laterally along the wall axis in ways it was not designed to resist. Portions of the concrete wall then failed in tension and fell off the wall, creating a gap several feet wide in the wall through which water gushed. Simultaneously, excessive tensile forces caused one of the sheets to tear, starting at the location where a previous tear had been poorly welded during prior construction. When the tensile forces transferred to the bottom of the sheeting, a connection with a third sheet failed from bottom-up, completely separating the southern and northern wall sections.

Failure of the concrete, tearing of the sheeting, and rupture of the connection likely occurred very rapidly, possibly creating the explosive sound heard by an eyewitness situated at a nearby pump station. I concluded that water gushing through the wall gaps rapidly eroded soil in front of the wall, allowing a segment to rotate outward and pull away from the transition. The eyewitness observed these events as described in his deposition. The steel object he described was likely the tops of three steel sheets he saw occasionally through the gushing water. As the canal water level continued to rise, land-side scour of the flood wall embankment caused the failure to

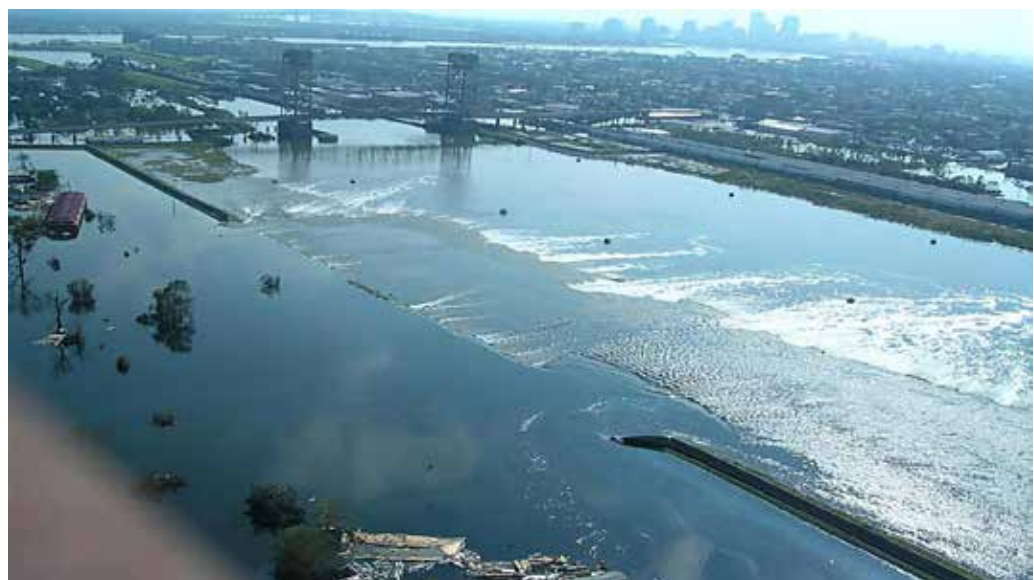
Figure 2. Photo at South Breach of IHNC. (Photo courtesy of USACE.)

I concluded that overtopping of the flood wall caused the South Breach. The overflowing water scoured away the soil

on the land side and removed the soil resistance that held the I-wall in place against the pressure of the rising water in the canal. My evaluation determined that the top of the wall was lower than previously thought (El. 12.1 ft versus El. 12.5 ft) at this location. This meant that overtopping and scour started earlier than previously thought. It also explains why the South Breach failure occurred where it did — at a low section at the top of the wall. Photographs of unfailed sections of the I-wall show that significant scour occurred, and some sections of the wall were rotated outward in the early phases of failure (Figure 3). Analyses show that sufficient scour depths could occur to cause the wall to fail by the top rotating outward and developing into an overturning failure. Aerial photographs show the progression of rotation from both ends of the South Breach. Remarkably, the sheeting remained connected despite being rotated from vertical to horizontal and stretched to 944 ft over the 820-ft length of the failed zone. Most of the concrete I-wall constructed on top of the sheeting had completely failed and fallen off. This was most likely the result of horizontal stretching of the sheeting as described for the North Breach.

Stability analyses showed that the flood wall at the South Breach could not have failed by global instability because the FOS against global instability likely never fell below 1.3. In fact, as the water level on the land side of the wall began to rise, the FOS against global instability increased. No team found any evidence to indicate the occurrence of a global instability within the foundation soils at the South Breach.

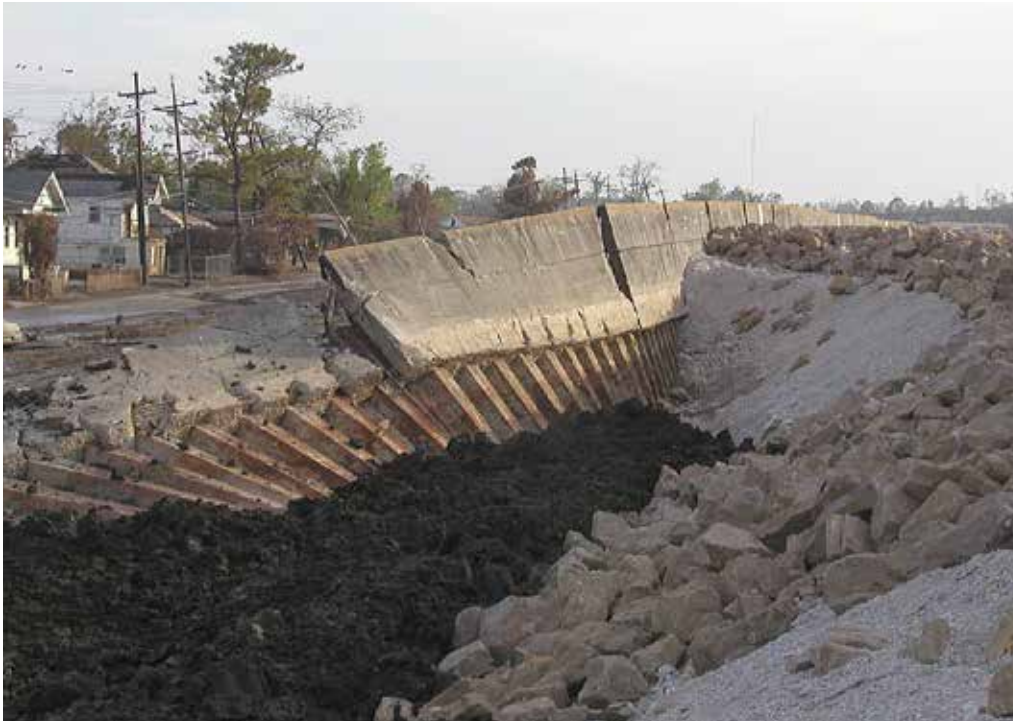
**Figure 3.** Rotated I-wall. (Photo courtesy of USACE.)
