## KEY FEATURES OF THE GEOTECHNICAL SAFETY PROGRAMME FOR THE AMUAY CLIFFSIDE

T. WILLIAM LAMBE,\* EDMUND K. TURNER,\*  
FRANCISCO SILVA,\*\* and W. ALLEN MARR\*\*\*

### SYNOPSIS

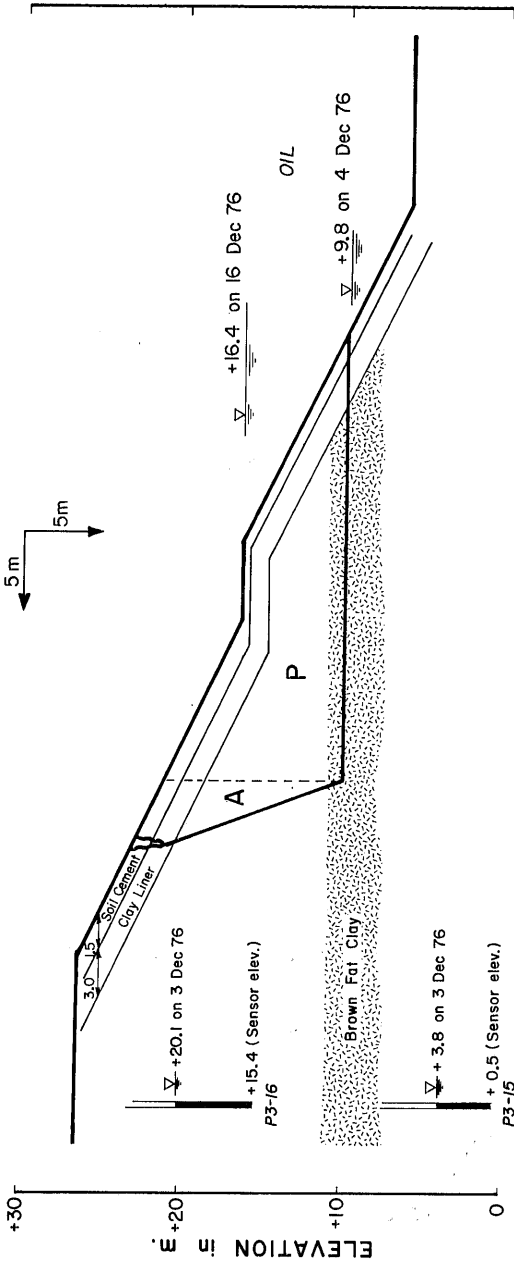
Fig. 3. Landslide-FORS-3, South East Wall, 16 December 1976.

During the last twenty five years instability of the cliffside has developed and the landslide which occurred in the southeast wall of FORS-3 in December 1976 typifies the slides which have occurred. Figure 3 shows a section of this slide. A vertical crack developed; a wedge, corresponding to an "active wedge" moved downward and away from the cliff; a wedge corresponding to a "passive wedge" moved nearly horizontally with the shear surface near the top of the layer of brown fat clay.

Development of "perched water" above the fat clay triggered the slides. Figure 3 shows piezometer readings above and below the fat clay just prior to

the FORS-3 slide. The development and rise in pore pressure from the perched water causes a drop in effective stress, and thus strength, which, in turn, causes a drop in strength parameters, and a rise in shear stress along a potential landslide shear surface. In spite of attempts to reduce the perched water, the water level has continued to rise. During the last two decades, various measures have been taken by LAGOVEN to stabilize selected regions of the cliffside. However, it is not feasible for LAGOVEN to stabilize once and for all the entire four kilometres of cliffside, since not only would such a "permanent solution" face technical problems but it would also cost hundreds of millions of dollars. Instead a comprehensive Geotechnical Safety Programme has been adopted that rests on:

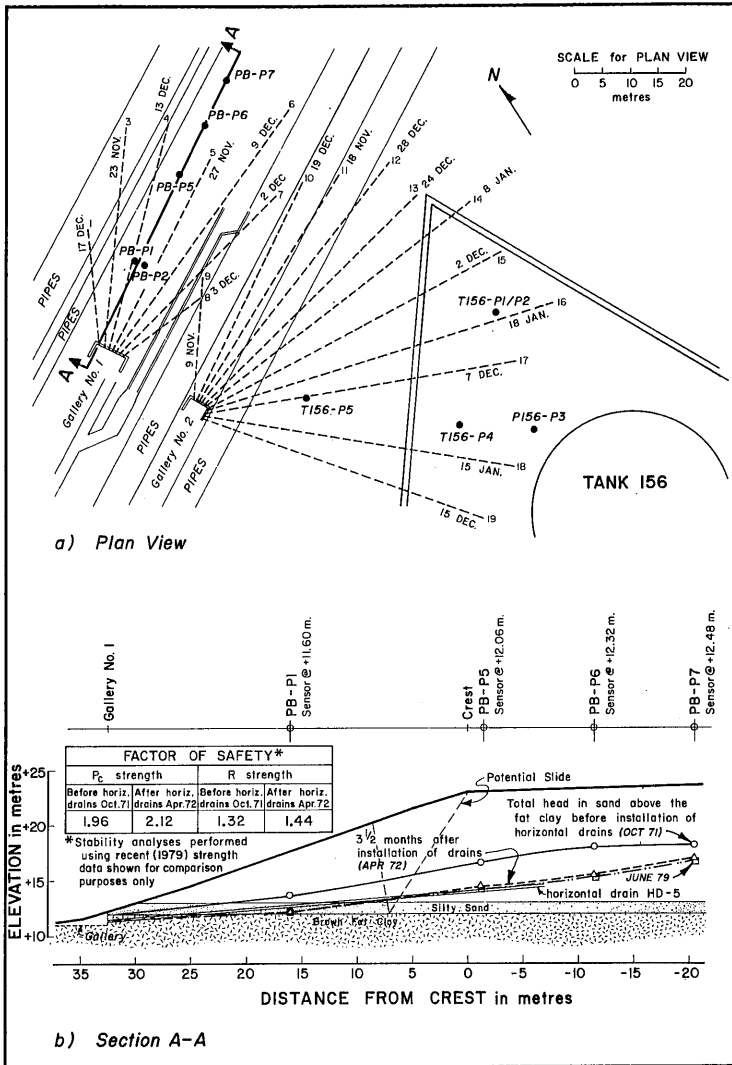
Fig. 14. Cliffside stabilization with lateral drainage.

Rising pore pressures in the perched water layer caused a deteriorating stability situation at the pipe band. Figure 14a shows two sections of the pipe band slope having a low degree of stability, and Figure 14b and Figure 15 show elevation views of these two sections.

In the late 1960's rising pore pressures in the pipe band area and the development of surface cracks led to the conclusion that the strength of the fat clay resisting a landslide was approaching the residual value. Stability predictions using residual strength parameters gave a factor of safety of 1.3 for Section A-A and 1.0 for Section B-B. The stability predictions indicated that within a few years Section A-A would have a factor of safety below the allowable minimum of 1.3 (see Figure 7) and that a landslide might well occur at Section B-B. Measures were therefore designed and executed to increase the factor of safety at each section to the 1.3 required in the performance criteria:

As indicated in Figure 14b, LAGOVEN installed 18 lateral drains at the pipe band. These lateral drains intercepted a layer of relatively pervious silty sand overlying the brown fat clay. The total head data plotted in Figures 14b and 15 show the magnitude and rate of total head drop. The pore pressure drop at Section A-A, effected by the lateral drains, increased the factor of safety to 1.4, a value greater than the minimum permissible value of 1.3.

LAGOVEN's experience with slope stabilization at the pipe band has shown that lateral drainage can dramatically lower total heads and thereby improve the degree of slope stability.

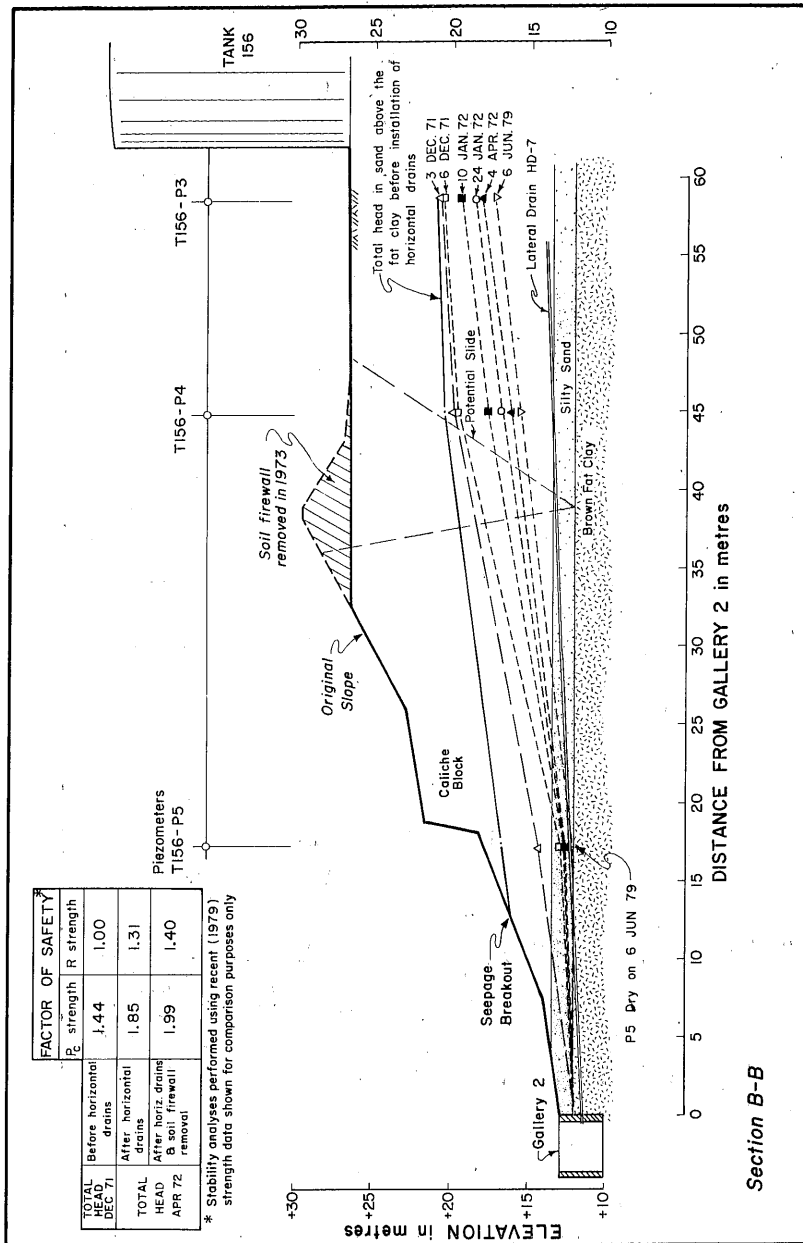
Fig. 15. Cliffside stabilization by unloading and lateral drainage.

Figure 15 shows factors of safety for Section B-B after the lateral drains reduced the total heads. The figure also shows the stability improvement effected by removing some of the slope and especially the fire wall. The safety factors shown in Figure 15 indicate that drainage alone improved the stability of Section B-B to the level required by the performance criteria. At the time the remedial measures for Section B-B were designed there was little confidence that the lateral drains would work as well as they did and therefore removal of the fire wall was requested as well as drainage at Section B-B.

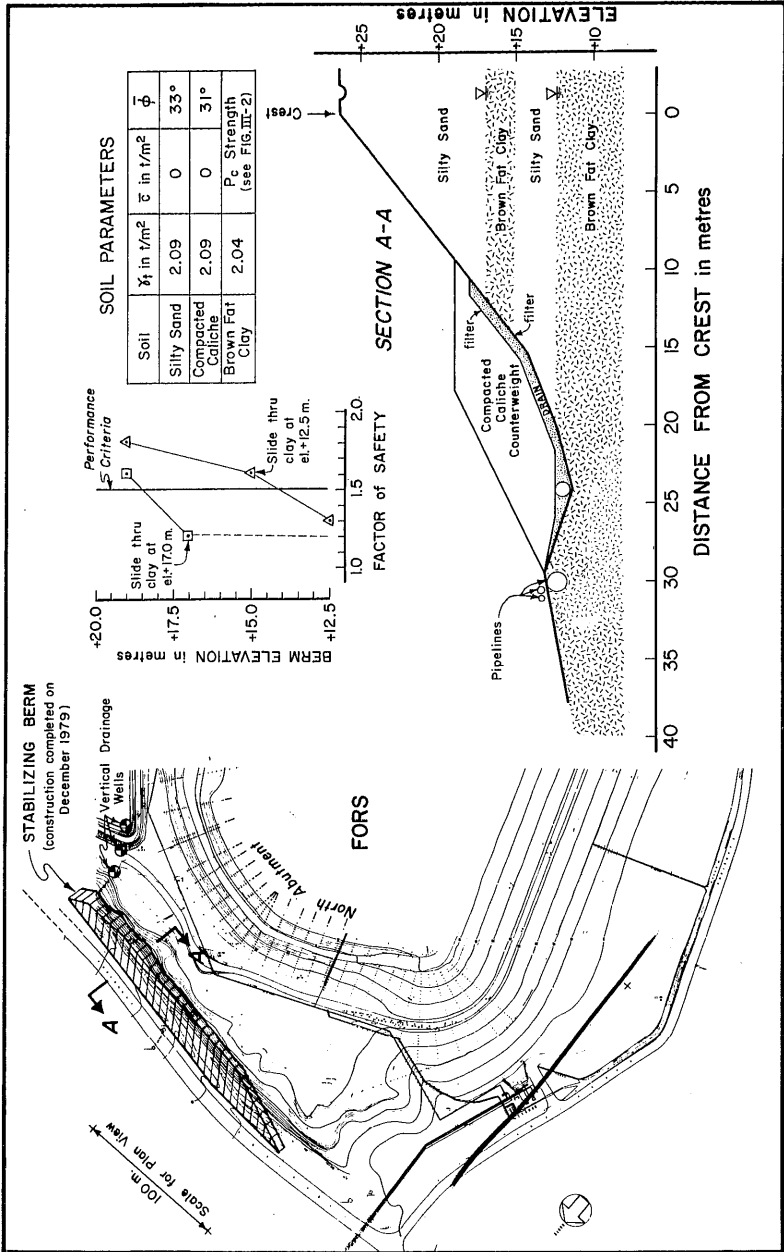
Fig. 16. Cliffside stabilization with a counterweight.

Rising pore pressures near the north abutment of FORS-1 caused a serious deterioration in stability. A landslide on the outside of the north abutment could have catastrophic effects, if it occurred when FORS-1 stored a large amount of fuel oil. Stability predictions for the outside of the north abutment of FORS-1 indicated a factor of safety of about 1.2, a value far below the minimum permitted by the performance criteria (1.5). Figure 16 shows a plan view of part of the north abutment of FORS-1 and an elevation view of Section A-A. Section A-A had the lowest degree of stability at the north

abutment. Figure 16 also gives predicted factor of safety as a function of elevation of the crest of the stabilizing berm. As the predicted safety factors indicate, a berm extending up to elevation +18.5 (along with drainage wells) should increase the factor of safety at the critical section of the north abutment to a value of 1.5, i.e. that required by the performance criteria. During 1979 LAGOVEN constructed the stabilizing berm.

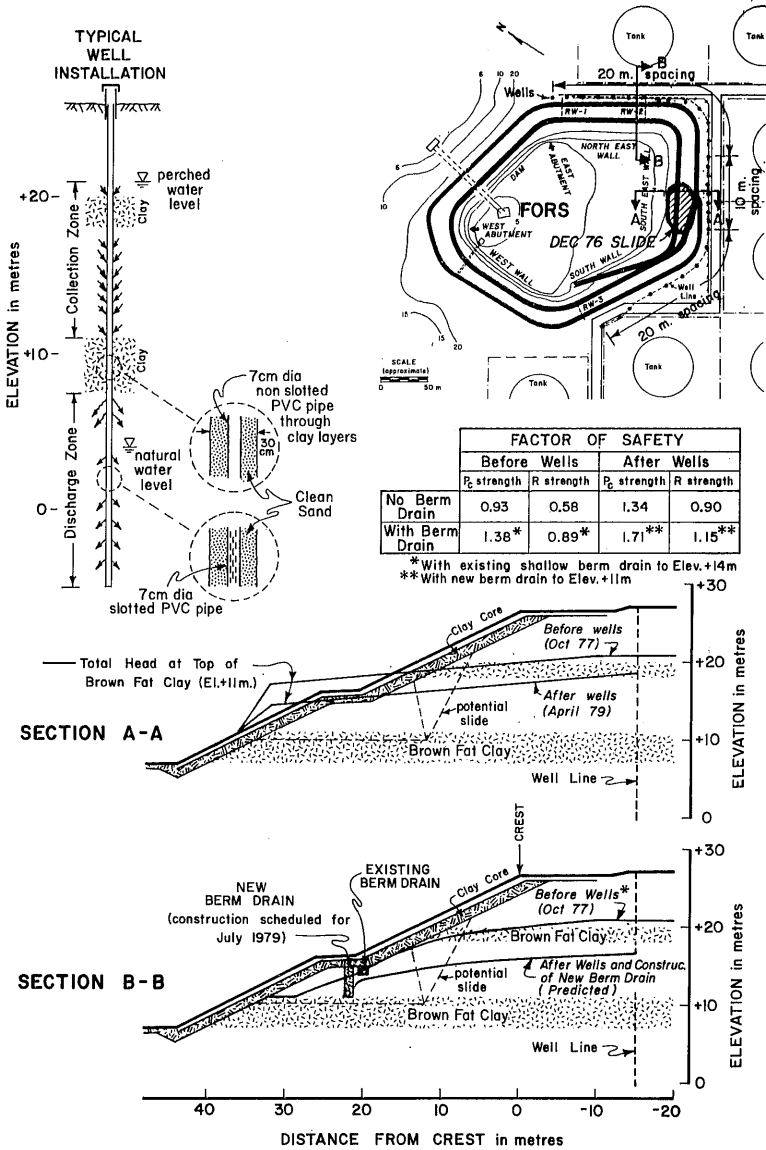
Fig. 17. Cliffside stabilization with drainage.

Rapidly rising pore pressures in the perched water caused concern for stability of the natural slope of FORS-3. Stability predictions made in the early 1970's indicated factors of safety considerably below those permitted by the performance criteria. In fact, stability predictions indicated the likelihood of a landslide occurring in the northeast wall of FORS-3. Figure 17 shows Section B-B, where a slide had been predicted. In hopes of preventing the landslide a system of vertical wells which would permit the perched water to flow through the layer of fat clay were designed and installed and the typical well installation is indicated in Figure 17. However, before LAGOVEN had installed the vertical drainage wells, a landslide occurred near Section A-A.

Figure 17 shows elevation views of Sections A-A and B-B. These elevation views also indicate the distribution of total head before well installation and the predicted distribution of total head after well installation. A berm drain in Section B-B helped lower total heads near the face of the slope at Section B-B. As calculated factors of safety presented in Figure 17 indicate, the drainage system installed in the natural hillside of FORS-3 should prevent further landslides.
