#### TVA'S INSTRUMENTATION AND MONITORING PROGRAM — HELPING MANAGE RISKS ASSOCIATED WITH WASTE IMPOUNDMENTS

W. Allen Marr, PhD, PE, NAE<sup>1</sup> Nicolas McClung, PE<sup>2</sup> Scott Turnbow, PE<sup>3</sup> Dori Ross, PE<sup>4</sup>

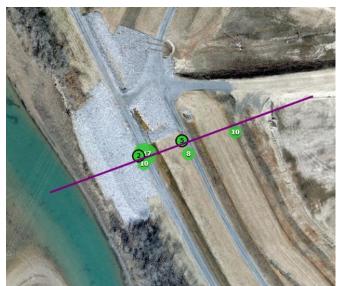
Figure 1. Plan for Section of Cumberland

A typical instrumented cross section is shown in plan in Figure 1 and in section in Figure 2. Figure 1 shows the containment berm built of natural soils with two benches. The grey-white material on the right side of the photo is stored ash.

Note: Figure is a screen capture from the iSiteCentral monitoring system. Aerial photo is scaled to project coordinates. Section and instruments are geo-located in a layer overlying the aerial photo. Circles indicate locations of instruments. Number in circle indicates number of sensors at each location. Green color indicates all sensor readings are within their normal range. Light colored material in the photo is rock material added to fortify the slope.

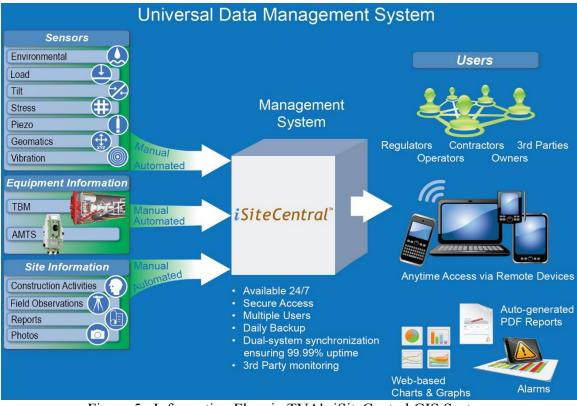
Figure 5. Information Flow in TVA's iSiteCentral GIS System

A schematic diagram showing the data flow and services being performed automatically by TVA's iSiteCentral GIS is shown in Figure 5. The automated instrumentation data are collected on field data loggers on pre-programmed intervals. The typical configuration on most sites is one reading every five minutes for the weather station, piezometers, pond level indicators and river level indicators; and one reading every hour for the in-place inclinometers. The data collected are uploaded into the TVA iSiteCentral system.

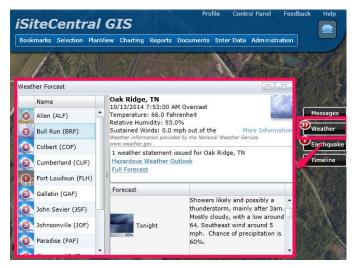
Figure 7. Rainfall Alert

Rainfall Alerts – One driving force behind some potential failure modes at the CCP disposal facilities is heavy rainfall. TVA's iSiteCentral has two focused services to identify and track rainfall events. The first is an integrated reporting of NOAA's weather station alerts and access to NOAA's weather data. Heavy rainfall warning

notices like that shown in Figure 7 are delivered to users to focus additional attention to the monitoring where and when appropriate. The second is a rainfall event tracking algorithm developed to provide information on storm severity (i.e. a 50 year storm) based on NOAA's published analyses. TVA uses this information to mobilize field staff to perform visual monitoring and inspection procedures so consequences of heavy rainfall can be identified early and managed.
