## KEY FEATURES OF THE GEOTECHNICAL SAFETY PROGRAMME FOR THE AMUAY CLIFFSIDE

T. WILLIAM LAMBE,\* EDMUND K. TURNER,\*  
FRANCISCO SILVA,\*\* and W. ALLEN MARR\*\*\*

### SYNOPSIS

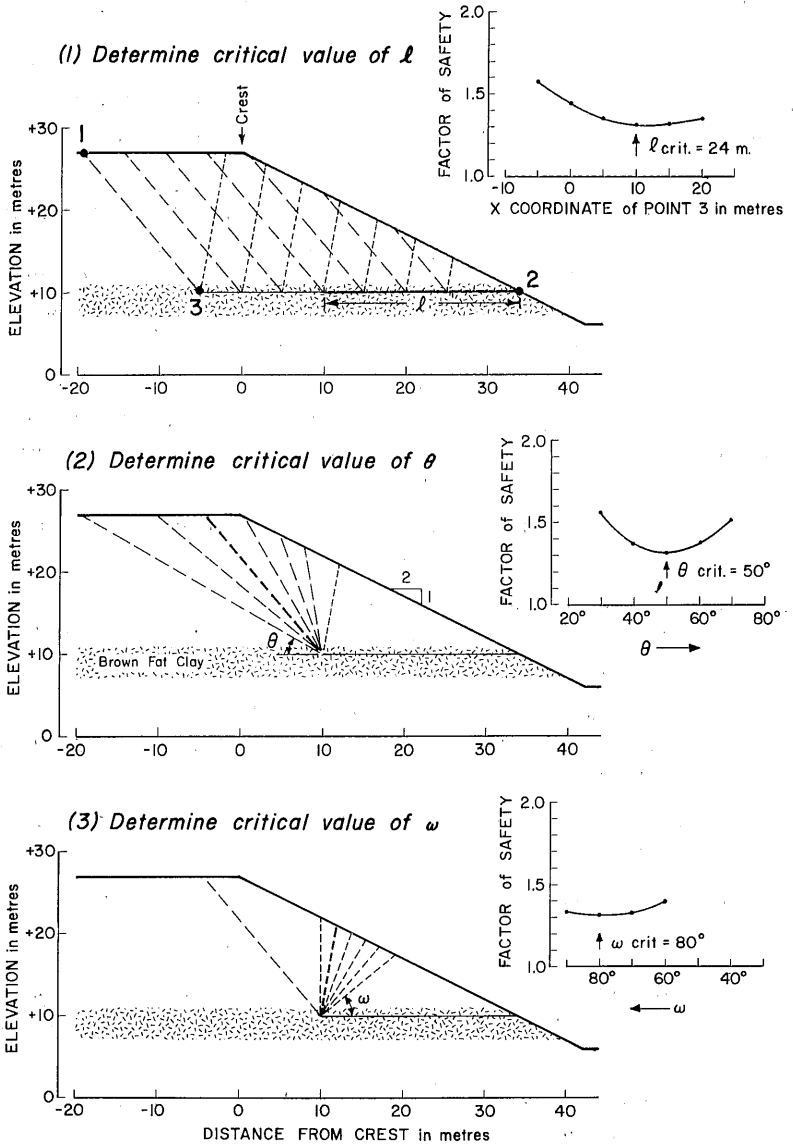
Fig. 8. Locating the critical failure surface.

Figure 8 illustrates the steps in locating the surface having the minimum calculated factor of safety. Figure 9 indicates the procedure for selecting the appropriate clay strength for a stability prediction. Considering the stage

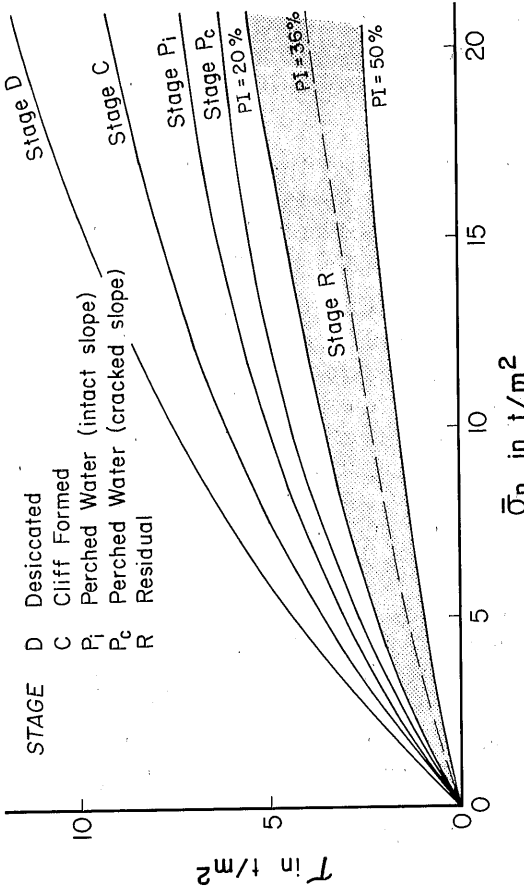
Fig. 9. Clay strength selection for stability prediction.

Stage at Present + 2 years	Stage at end of Design Life	Applicable Strength	
		Assessment	Design
D	D	D	use C
	C	D	C
	Pi	D	Pi
	Pc	D	Pc
	R	D	R
C	C	C	C
	Pi	C	Pi
	Pc	C	Pc
	R	C	R
Pi	Pi	Pi	Pi
	Pc	Pi	Pc
	R	Pi	R
Pc	Pc	Pc	Pc
	R	Pc	R
R	R	R	R

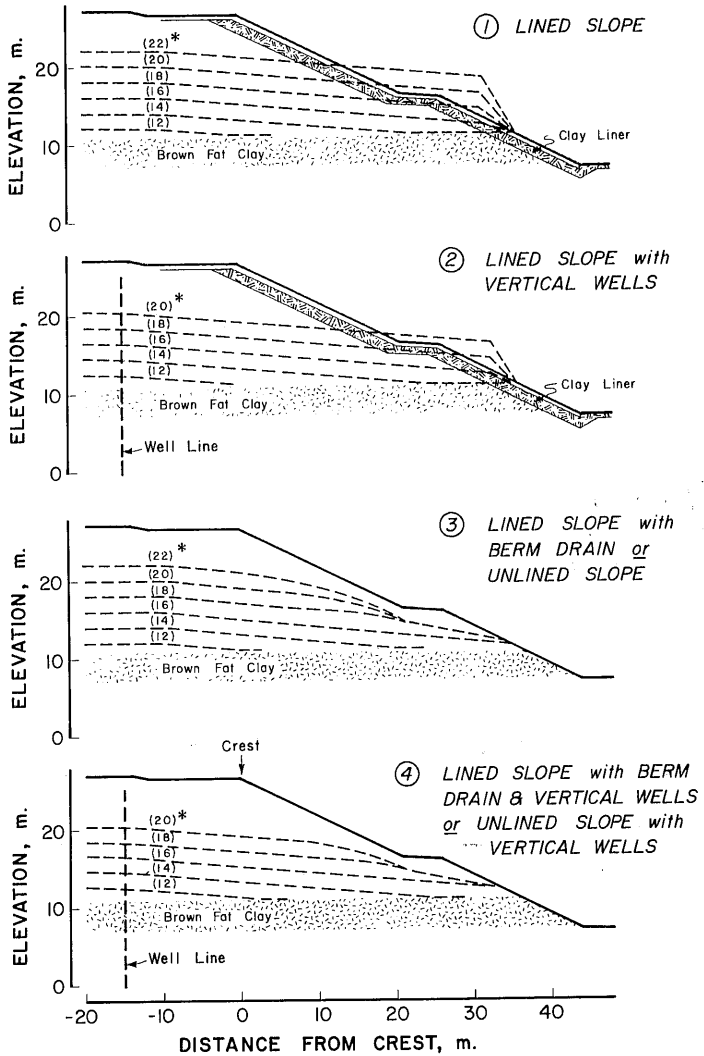
**Fig. 10. Selection of pore pressure for stability prediction  
Stability analysis interim guidelines.**

Figure 10 presents the procedure for selecting the pore pressure for a stability prediction. The pore pressure distribution used in the stability prediction comes from extrapolating an actual measured or a predicted value of total head at a piezometer 10 metres away from the crest of the slope using Figure 10. Use of this "steady state" pore pressure has been found to give the correct factor of safety for an actual landslide. Using the pore pressure for steady state seepage prior to a slide for the prediction of a slide is a matter of concern since this procedure neglects any excess pore pressure developed by straining associated with the landslide.

\* dashed lines give Total head distribution at top of Brown Fat Clay for total head = (#) @ -10m. from crest

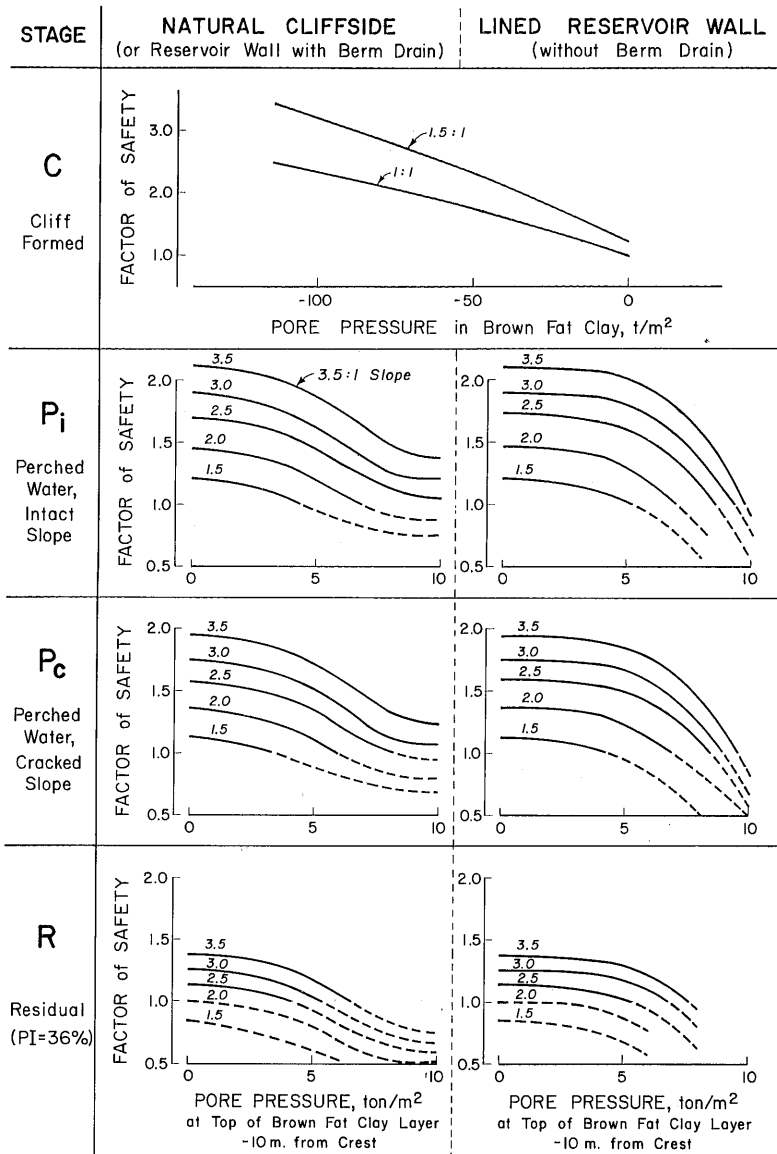
Fig. 11. Stability charts.

Figure 11 presents charts for making a stability prediction, and these charts are used for an initial assessment of stability. If the factor of safety obtained from the stability charts exceeds the value allowed by the performance criteria by 20% or more the results obtained from the charts are used. If the chart solution does not exceed the performance criteria by 20%, the slope is further investigated using analyses with detailed conditions.

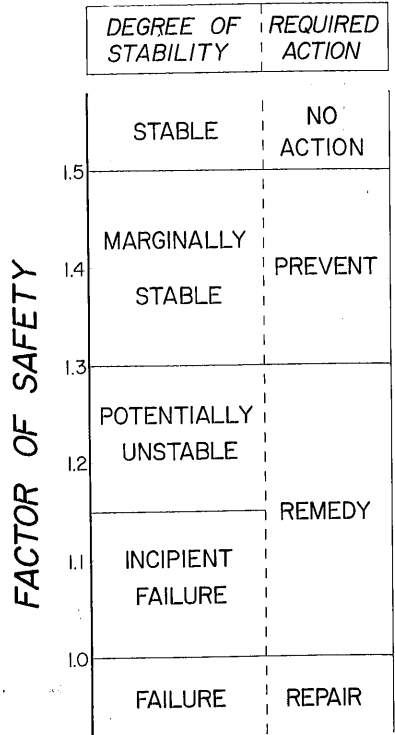
Fig. 12. Required action as function of degree of stability.

In the Geotechnical Safety Programme, the degree of stability for a given slope is determined and then recommendations given for appropriate action. Figure 12 relates "degree of stability" and "required action" for the earth dams and especially the abutments of the oil storage reservoirs. The term "preventive measure" is used to cover actions (e.g. drainage from wells above the slope) taken away from the slope in question, whereas the term "remedial measure" is used to involve an action (e.g. flatten the slope) on the slope itself.

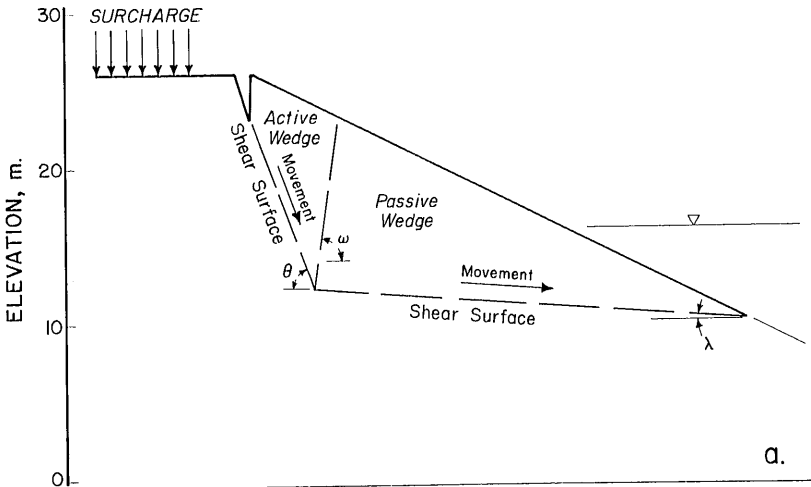
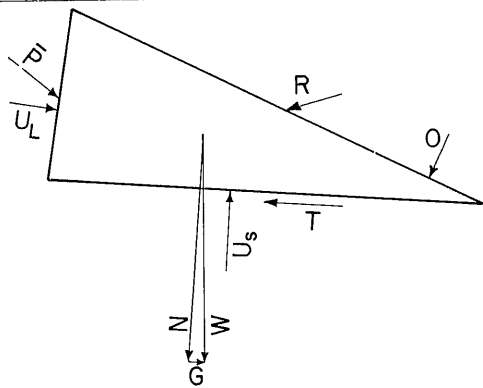
Fig. 13. Landslide forces.

Figure 13 shows a free body for the passive wedge of a potential slide. Using Figure 13, the possible means of improving stability of a slope have been considered. In general, stability has been improved by taking measures which do one of the following:

- $U_L$  = Lateral Water Force
- $\bar{P}$  = Lateral Soil Force, including effect of Surcharge
- $G$  = Gravity Effect =  $W \sin \lambda$

- (1) reduce  $U_L$  (install surface drainage uphill of the slope (install vertical drainage);
- (2) reduce  $\bar{P}$  (reduce any surcharge on the cliff near the crest of the slope, strengthen the soil in the active wedge);
- (3) reduce  $G$  (remove some of the passive wedge, replace some of the passive wedge with a material of lower unit weight).

- (1) increasing the strength parameters of the soil (chemical means, electrical means, temperature, replace weak soil with stronger soil, overload);
- (2) reducing  $U_s$  (install vertical or horizontal drainage);
- (3) increasing  $O$  (raise the level of oil in the reservoir);
- (4) increasing  $R$  (construct berm, install tie backs, install retaining wall).
