TVA'S INSTRUMENTATION AND MONITORING PROGRAM — HELPING MANAGE RISKS ASSOCIATED WITH WASTE IMPOUNDMENTS

W. Allen Marr, PhD, PE, NAE¹
Nicolas McClung, PE²
Scott Turnbow, PE³
Dori Ross, PE⁴

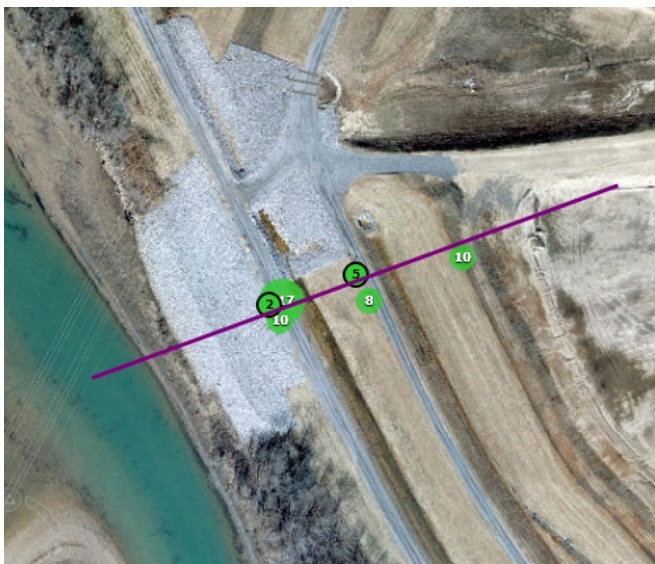
Figure 1. Plan for Section of Cumberland

Note: Figure is a screen capture from the iSiteCentral monitoring system. Aerial photo is scaled to project coordinates. Section and instruments are geo-located in a layer overlying the aerial photo. Circles indicate locations of instruments. Number in circle indicates number of sensors at each location. Green color indicates all sensor readings are within their normal range. Light colored material in the photo is rock material added to fortify the slope.

A typical instrumented cross section is shown in plan in Figure 1 and in section in Figure 2. Figure 1 shows the containment berm built of natural soils with two benches. The grey-white material on the right side of the photo is stored ash.

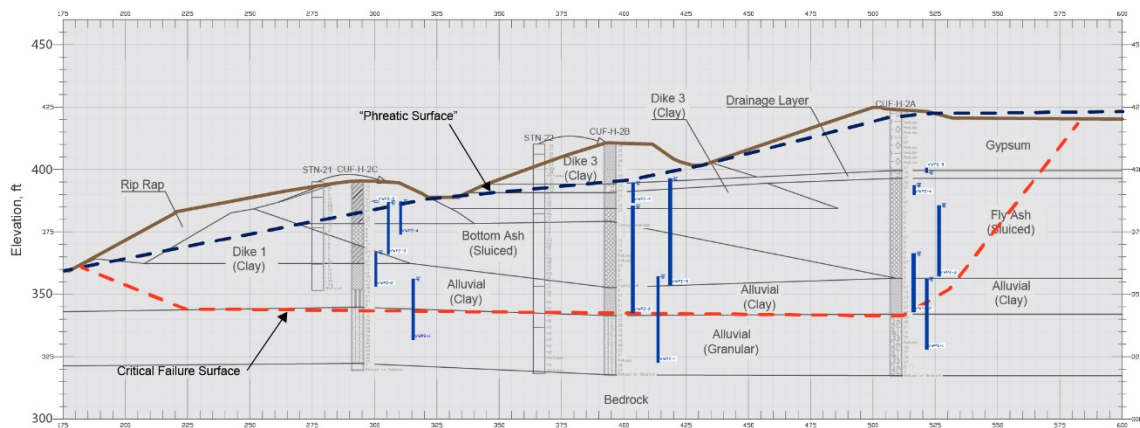
Figure 2. Cumberland Cross Section

The cross section in Figure 2 has a red dashed line showing the critical failure surface for global stability. The upper orange dashed line shows the phreatic surface used by the geotechnical engineers to assess global stability in 2010-2011. The analyses calculated the pore pressures for the entire cross section using this piezometric surface. Vertical blue lines indicate pore pressure measurements made in 2012 using grouted in place piezometers. The bottom of the line indicates the elevation of the sensor. The top of the line indicates the piezometric head measured by the sensor. All piezometers in the lower part of the cross section indicate pore pressures much less than one would obtain using the shown phreatic surface. Using the measured pore pressures rather than the assumed single phreatic surface resulted in a significant increase in the calculated factor of safety for global stability for both static and earthquake loading. The data from these piezometers helped TVA avoid significant remedial work and save millions of dollars.

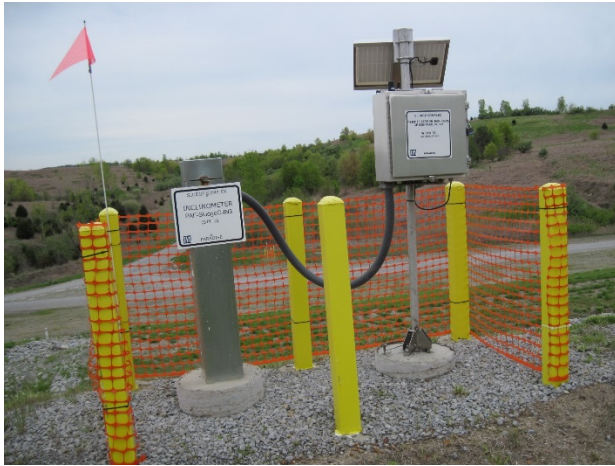
Figure 3. Typical TVA instrument station

IP or Internet modem at each site receives the radio signals and forwards them to the central data servers at TVA's headquarters in Chattanooga, Tennessee. Figure 3 shows a typical installation of data logger, solar power supply and radio at an instrument location.

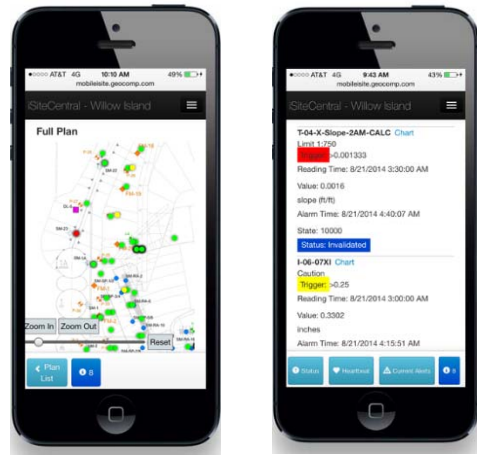
Figure 4. Software app showing sensor status

Experience at TVA has shown that conditions can change over a few minutes so electronic instruments are read every five minutes and the readings are compared to previous readings and preset limit values. Manual readings of non-electronic instruments are taken by TVA personnel and then input into TVA's data management system while the person is still at the instrument location. This is done using a software app on a phone or tablet. Figure 4 shows one app that gives a map showing instrument locations and sensor status as well as a screen that displays the current reading of any sensor.

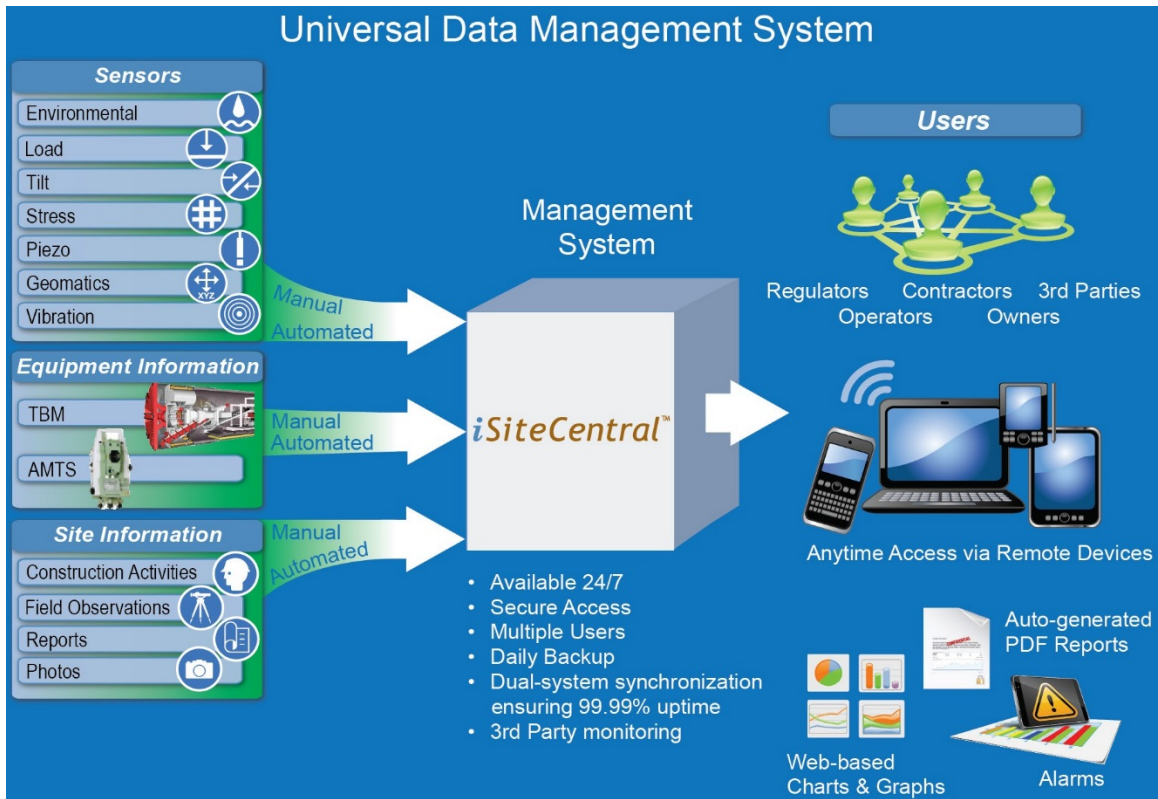
Figure 5. Information Flow in TVA's iSiteCentral GIS System

A schematic diagram showing the data flow and services being performed automatically by TVA's iSiteCentral GIS is shown in Figure 5. The automated instrumentation data are collected on field data loggers on pre-programmed intervals. The typical configuration on most sites is one reading every five minutes for the weather station, piezometers, pond level indicators and river level indicators; and one reading every hour for the in-place inclinometers. The data collected are uploaded into the TVA iSiteCentral system.

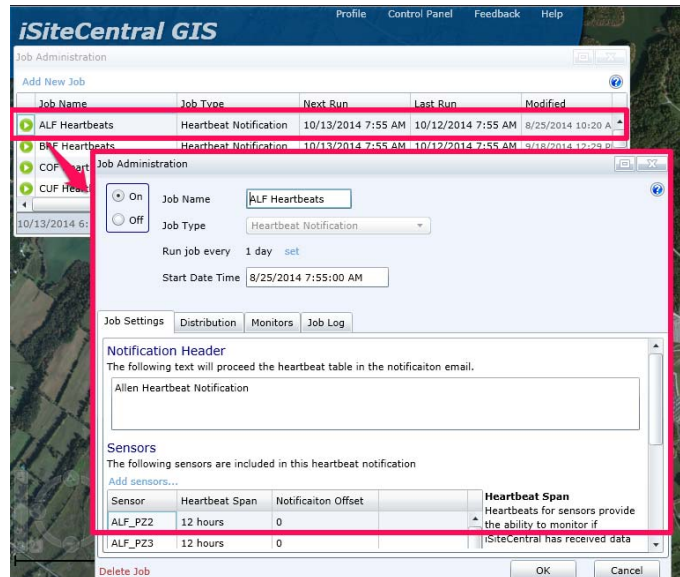
Figure 6. Heartbeat job detail

Heartbeats – the system has a user-defined threshold called the *Heartbeat Span*. When the time between the current time and the last posted reading exceeds the Heartbeat Span, an alert like that shown in Figure 6 is issued to indicate that something is not working to deliver data when expected. The Heartbeat Span is configurable for each individual sensor or as groups of sensors. Heartbeat Jobs are created and scheduled for any list of sensors and any user or user group.

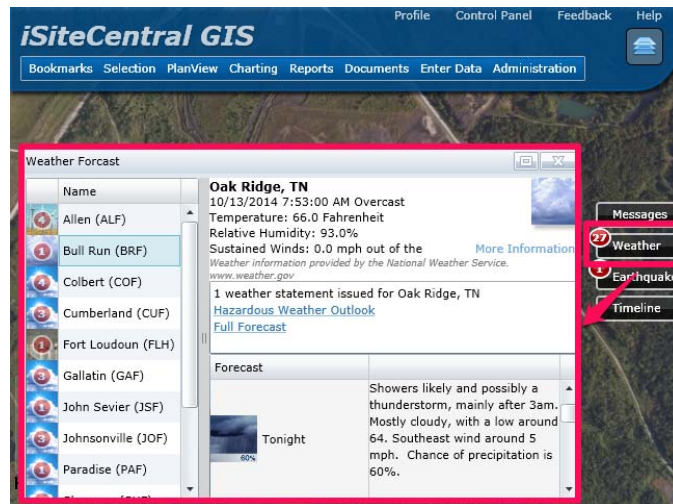
Figure 7. Rainfall Alert

Rainfall Alerts – One driving force behind some potential failure modes at the CCP disposal facilities is heavy rainfall. TVA’s iSiteCentral has two focused services to identify and track rainfall events. The first is an integrated reporting of NOAA’s weather station alerts and access to NOAA’s weather data. Heavy rainfall warning notices like that shown in Figure 7 are delivered to users to focus additional attention to the monitoring where and when appropriate. The second is a rainfall event tracking algorithm developed to provide information on storm severity (i.e. a 50 year storm) based on NOAA’s published analyses. TVA uses this information to mobilize field staff to perform visual monitoring and inspection procedures so consequences of heavy rainfall can be identified early and managed.

Rain Data - Rainfall notifications are programmed to alert engineers, field staff and management when threshold events are exceeded. At least three events in 2013 and 2014 triggered field staff and operational staff to mobilize to several CCP impoundments and visually monitor saturated slopes and swollen ponds. These notifications helped TVA to successfully reduce risks from overtopping of dikes and slope instability.
